Airbus China Safety Conference
Chengdu, 15-16 July 2015

CFIT

The right things to do to avoid it

Presented by Alan CHEUNG

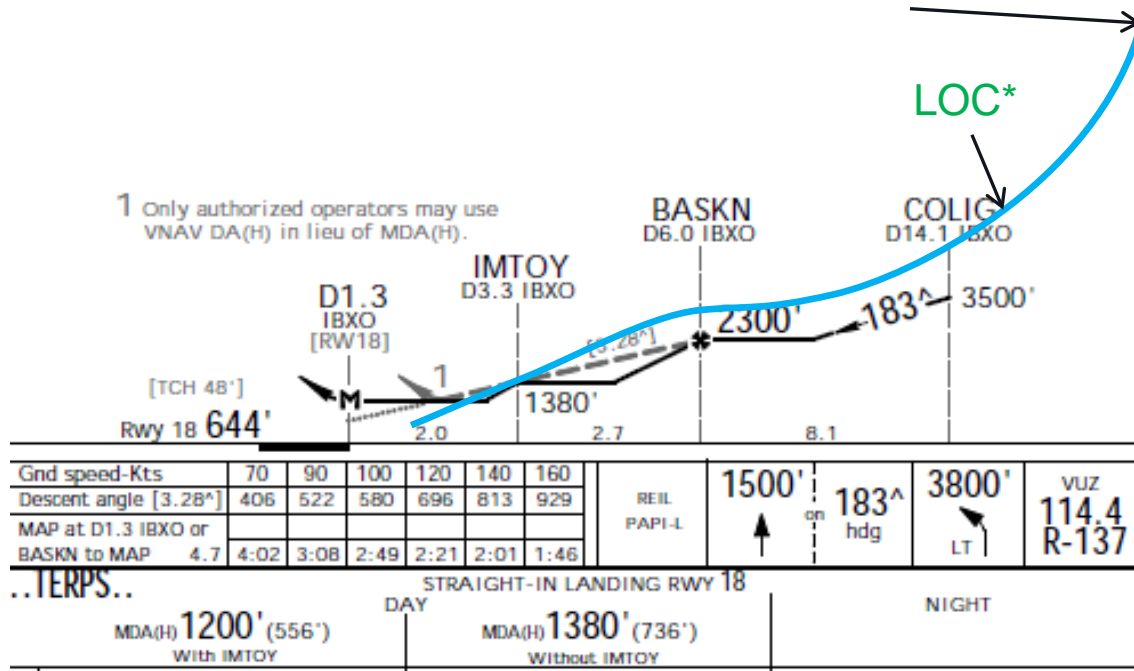
- Non Precision Approach
 - “Profile” approach initially briefed.
 - Changed later to V/S
- Crew/Tower misunderstanding
 - Procedure not followed
 - A/C levelled off at 2500ft
 - FAF overflown by +200ft

“UPS 1354 heavy is 11 miles from BASKIN maintain 2500 till established on localizer. Cleared LOC 18 approach.”

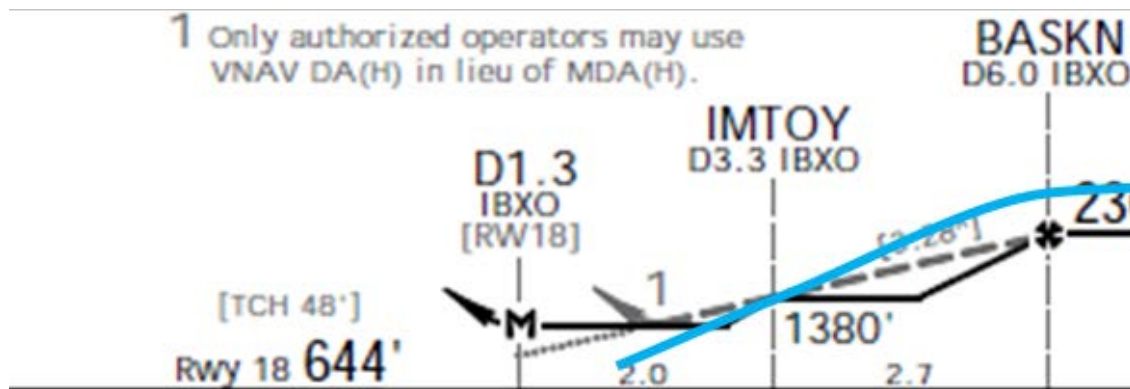
- Weather
 - Reported weather: Ceiling BKN010, OVC075, Vis 10SM
 - Weather worse than expected: RMK CIG 006V013 (not available to the crew)
- Descended below MDA (1200ft)
 - No callout from Pilot Monitoring

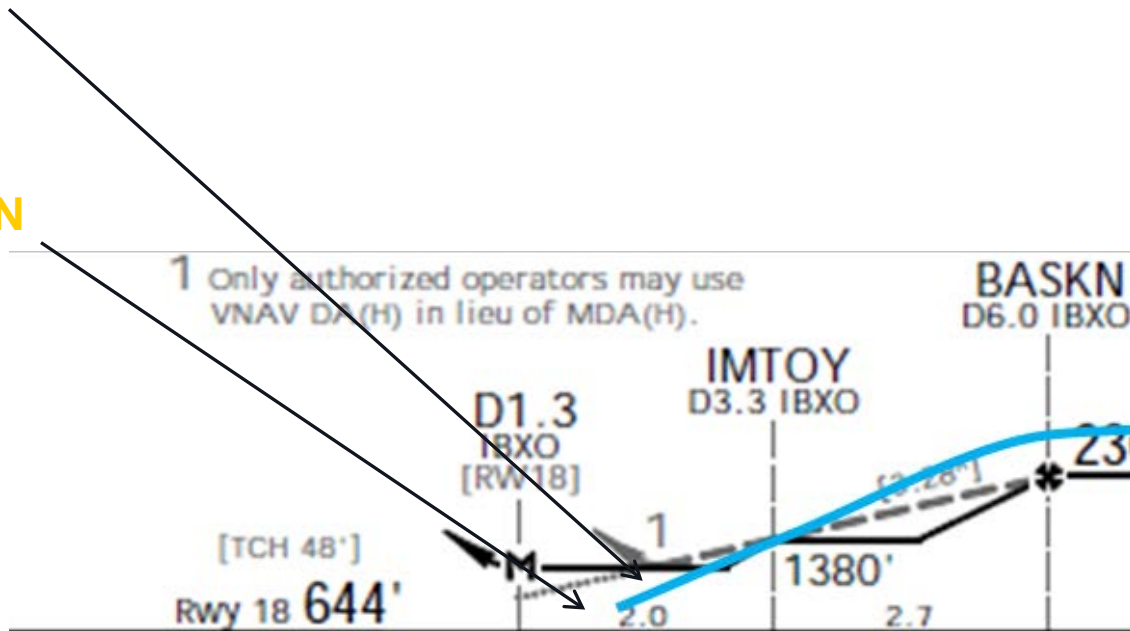
- TAWS caution **SINK RATE** (262ft AGL, 1015ft QNH)
 - Rate of descent reduced
 - 2 seconds after “*There it is*”
 - TAWS caution **TOO LOW TERRAIN**
 - After trees impact
 - A/C fitted with EGPWS
- P/N 965-0976-003-212-212
