The Airbus Safety Magazine

Edition July 2012

Issue **14**

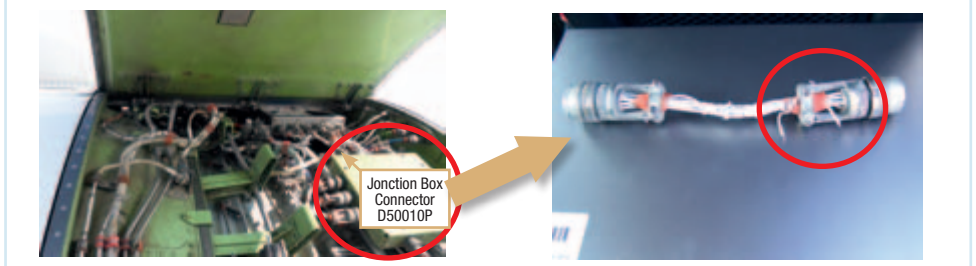
note 2

A defective pin at connector level (junction box D5010P) was at the origin of the electrical restow circuit failure.

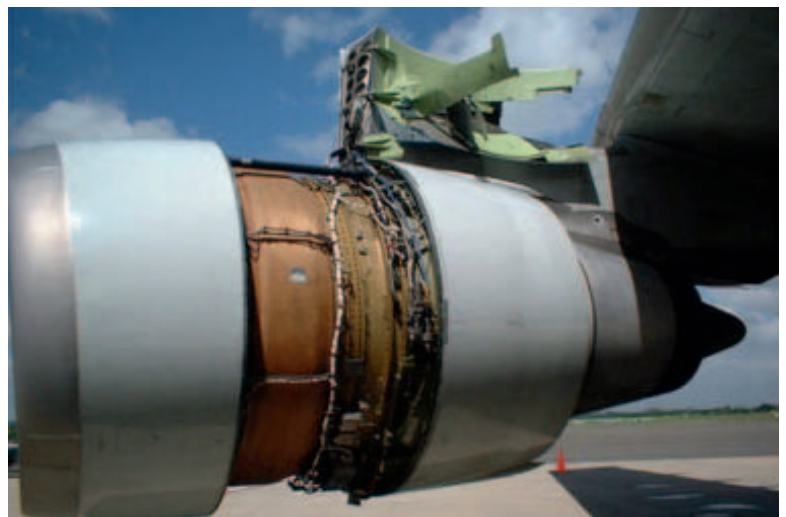
A fan cowl loss generally leads to twisted pylon cantilevers and/or minor damages to slats, wing leading edges, horizontal stabilizers and fuselage skins.

skin panel perforation or serious damage to the vertical or horizontal stabilizers. This type of damage represents a major hazard in terms of handling in flight and also often requires major repair work to rectify on the ground.

Figure 1
Fan cowl loss event

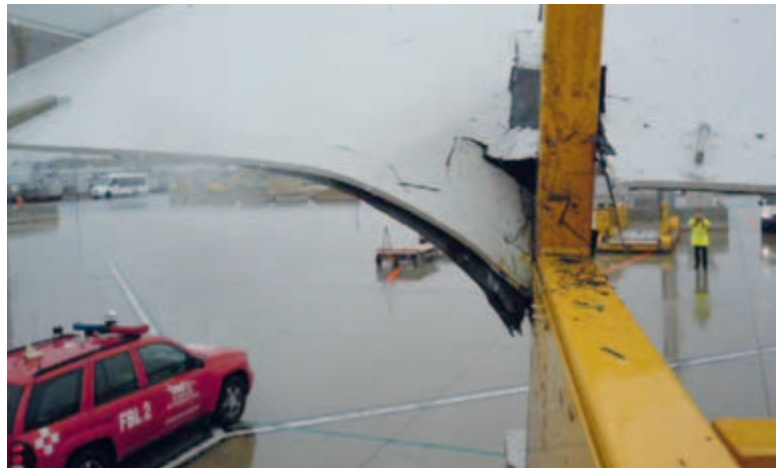
Figure 2
A possible consequence of the lack of awareness in the hangar
