The Airbus Safety Magazine

01 | January 2005 |

Go-Arounds at Addis Ababa due VOR Reception Problems

As far as aeronautics systems are concerned, the pre-flight flight controls (F/CTL) check has existed since before the first powered flight. It aims at ensuring that flight controls respond to the pilot inputs, i.e. with no jamming, or movement limitation, or stiffness, or delayed or inadequate response. It is thus a key factor in the safe operation of the aircraft.

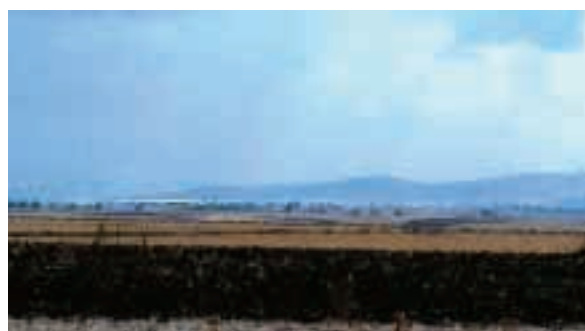
This picture shows the same ridge from a range of about 8nm from the NW of Leghedadi.

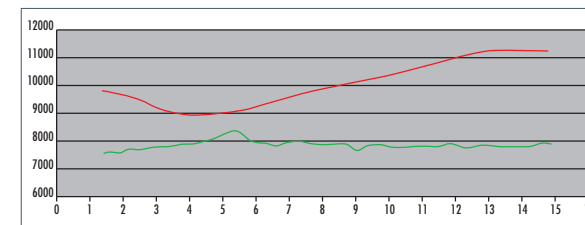
Figure 2 shows the profiles for the first approach at HAAB. Notable points are the non-sloping nature of the terrain between 15nm and 6nm and the high point at just over 5nm. There is also a marked valley at 9nm and a lesser one at 6.5nm.

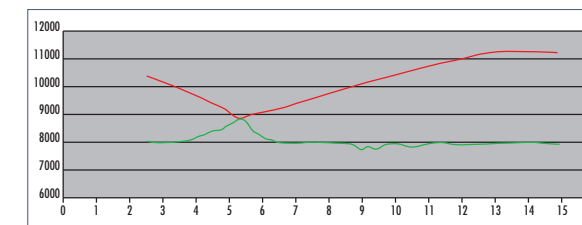
Figure 3 shows the profiles for the second approach at HAAB. Here, the notable points are again the flat terrain between 15nm and 7.5nm and the high point at just over 5nm. The river valley is still apparent at 9nm, but has split into two. The terrain clearance at the point of go-around is 55'.

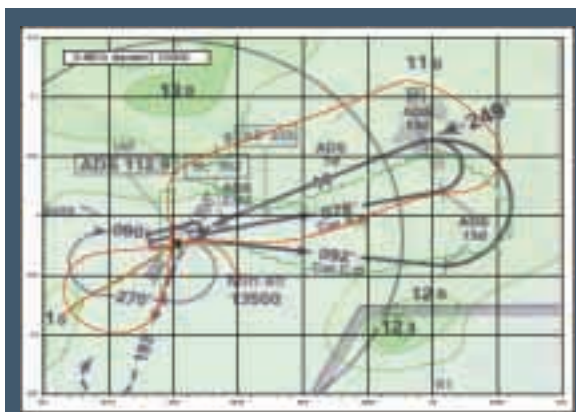
Figure 4

- During the outbound leg of the procedure, the VOR bearing information correlated with the GPS derived FMGC data on the Navigation Display (ND).
- As the aircraft turned left to intercept the 249°M track inbound to the VOR, the beam bar initially moved in as expected to near centre.
- As the wings were levelled on a heading that should have followed the correct track, the beam bar moved back out to the right and settled at about half to two thirds full scale deflection.
- The crew flew by visual reference to the runway using the GPS derived navigation data to follow the correct inbound track and the VOR indication remained steady at the deflection stated above.
- At about 3.5D, the beam bar quickly moved back to the central position.

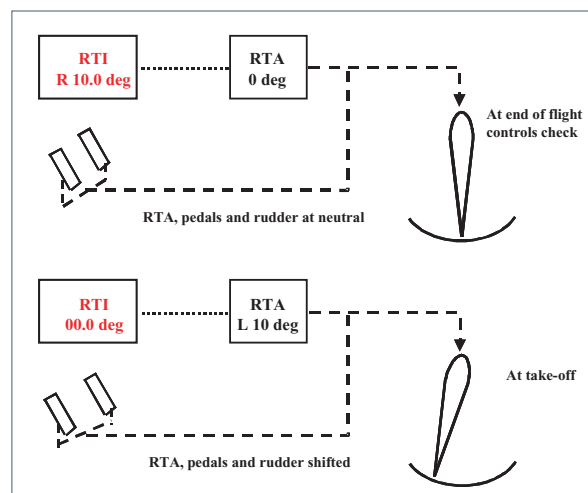
Rudder trim actuator (RTA) had to be at neutral also. Indication was erroneous.

Rudder trim indication was manually brought back to neutral with no further check. This shifted the rudder, the rudder trim actuator and the pedals out of neutral.

Figure 2 : incorrect rudder trim indication

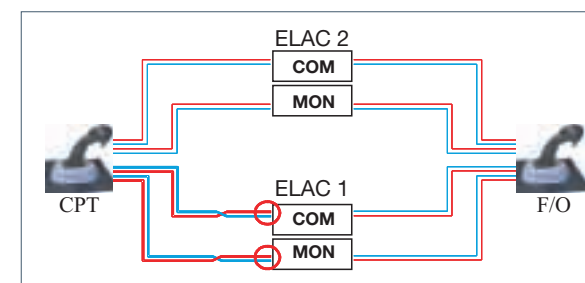
Upon troubleshooting, a maintenance error was found. A wiring inversion had been made between the transducer unit of Captain roll sidestick and ELAC 1, on both the COMMAND & MONITOR channel. With this double inversion, ELAC 1 was receiving consistent signals, and thus could not detect the anomaly and could not trigger a warning to the crew (Figure 3).

Figure 3: Cross connection of sidestick roll signals to F/CTL computer

The functional check required after performing AMM tasks had partially been performed on the F/O side only, and thus the anomaly was not detected by mechanics. Crew missed the last opportunity to detect it by not carefully performing the existing SOP F/CTL Check.

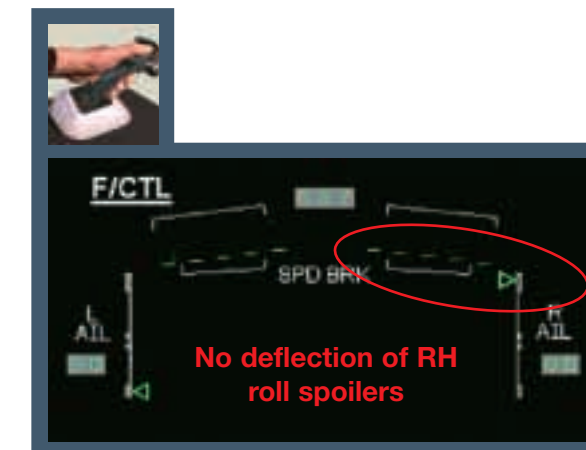
During a previous maintenance task, R/H spoilers 2 to 5 were left in the maintenance position. After lift-off, they deployed to the zero hinge moment positions and would not respond to inputs.

Figure 4: Lack of response from RH spoilers to sidestick inputs

Preventive instructions have been added in AMM, and monitoring has been improved to trigger an ECAM warning in such condition. But it could also have been detected by carefully performing the existing SOP F/CTL Check (Figure 4).

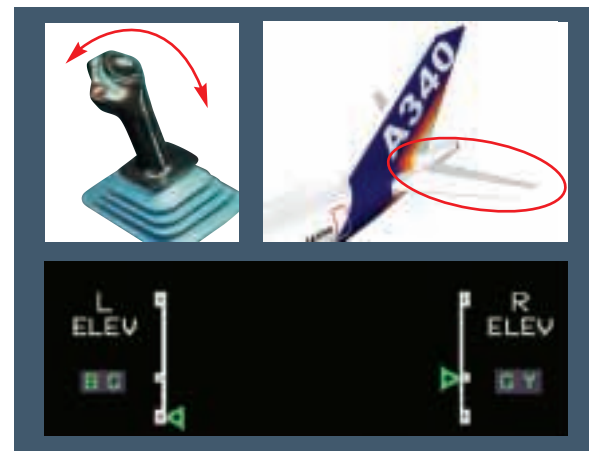
Figure 5

A few events of this kind have been experienced with aircraft of the A340 family. The crew detected during the pre-flight F/CTL check that one elevator was stuck down (Figure 5). The loss of the elevator control was not indicated to the crew by any warning.

These events resulted from failure of the servo-control in damping mode failed. Investigating these events has allowed definition of modifications to both the servocontrols and the F/CTL computers in order to prevent similar events. Appropriate ECAM warnings are triggered for crew annunciation. For these events, detection was ensured by carefully performing the existing SOP F/CTL Check only. Additional information about these event is available with

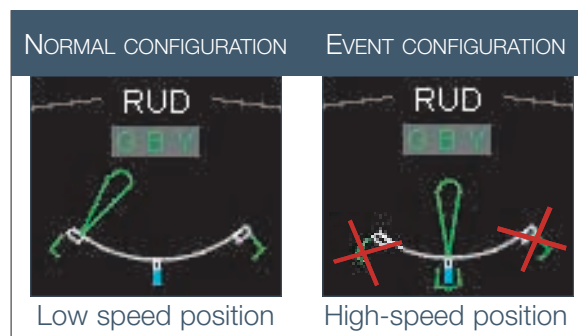
The Rudder Travel Limitation Unit (RTL) had failed closed in the high-speed configuration. The ECAM warning "F/CTL TRAVEL LIM FAULT" dedicated to the monitoring of the RTL position was not displayed.

Indeed, at that time, FCSC which is the computer that controls the RTL and PTLU did not monitor their behaviour during phases when they are not electrically supplied and thus not supposed to move. However the RTL system failed and RTL closed during such a phase of no monitoring on ground. Monitoring has since been reviewed.

Figure 6: Full rudder deflection not achieved

The failure was thus detected only by performing the existing SOP F/CTL Check, and the right decision to return to the gate could be taken.

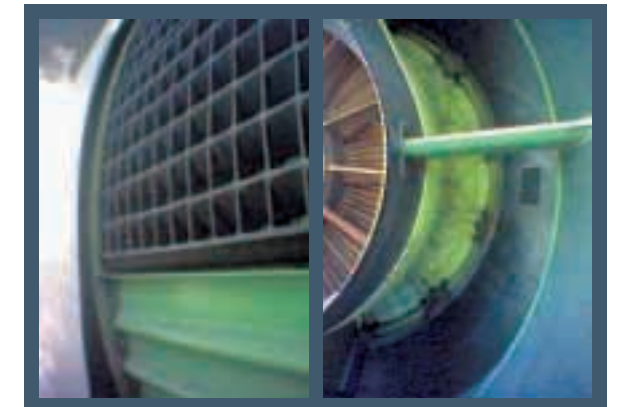
Figure 1

- Upon landing, the engine N° 1 reverser was found almost fully deployed.

- The thrust reverser sleeve locking pins (2) were not found, while the lock-out assembly was intact.
- After opening the fan cowls, both locking actuators were found lock wired in the unlock position. The HCU was properly deactivated.

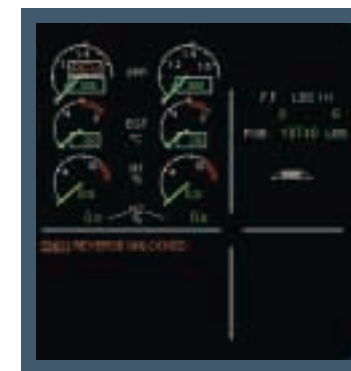
Figure 2

Prior to engine start, the ECAM warning “ENGX REVERSE UNLOCKED” was annunciated.

According to information received, maintenance personnel cancelled the “ENGX REVERSE UNLOCKED” message through the “EMER/CAN” button.

In addition, the "EMER/CANC" button should only be utilized to kill a permanent spurious warning.

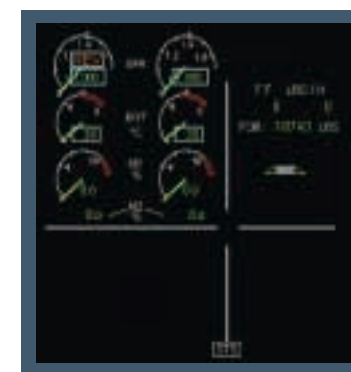
Figure 3

Upon engine start, the “ENGX REVERSE UNLOCKED” warning was then displayed under cancelled cautions, while the ECAM showed “REV” Amber in EPR gauge and “STS” indication.

The "ENGX REVERSE UNLOCKED" and the "REV" Amber messages should not be present on ECAM following a proper thrust reverser deactivation. **They are both NO DISPATCH warnings.**

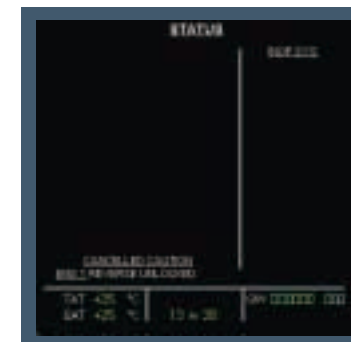
Figure 4

However, the aircraft was dispatched with the thrust reverser unlocked and free to move under aerodynamic forces.
