The Airbus Safety Magazine

03 | December 2006

Trimmable Horizontal Stabilizer Damage

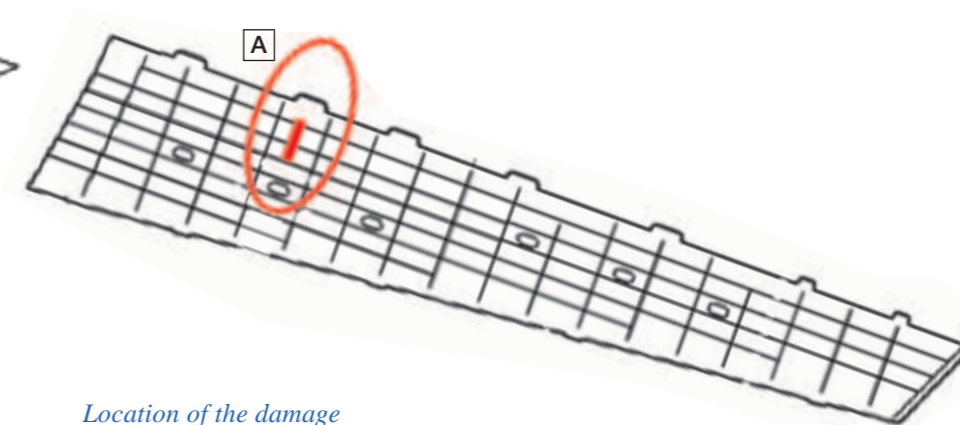
Location of the damage

On 21st of August 2004 upon landing, the subject airplane was found with a torn lower skin of the right hand THS Lateral Box. This damage was thought to be due to a Foreign Object Damage (FOD) and resulted in a leaking Trim Tank.

A missing water servicing door (164AR) was suspected to have caused the damage. The damage was inspected externally only. The external cut was measured to be about 330mm length by 3mm width, in line of flight, located at the THS bottom skin panel, just behind second THS inboard handhole access panel.

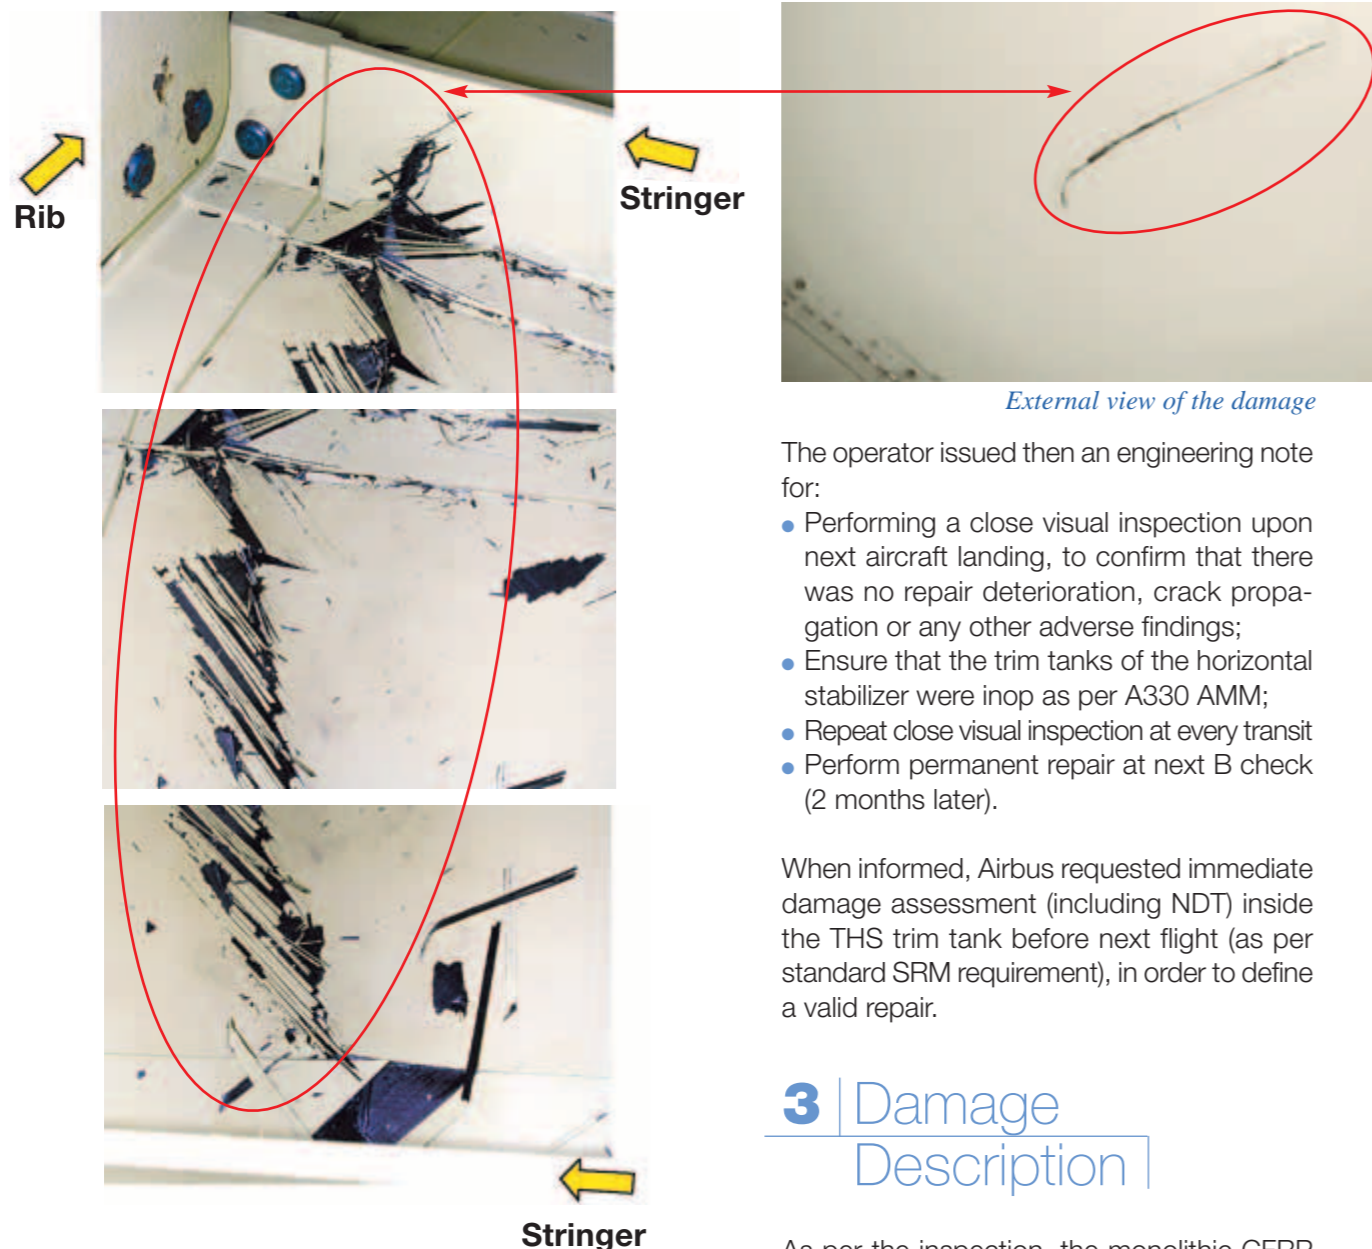
External view of the damage

The visible damage is shown on the picture: Based on external visual findings, the operator performed a temporary repair, by filling the damage

As per the inspection, the monolithic CFRP panel was found cracked throughout the cut length, with large delaminations in the surrounding area.

Two stringers located on the THS bottom skin panel had been severely damaged.

The aircraft required immediate appropriate repair, as the temporary repair did not restore the required structural integrity of the THS.

When informed, Airbus requested immediate damage assessment (including NDT) inside the THS trim tank before next flight (as per standard SRM requirement), in order to define a valid repair.

"...All instructions for inspection and repair of composite structure given in the SRM are to be followed, to detect damage in its full extent, and to prevent [...] inappropriate repair"

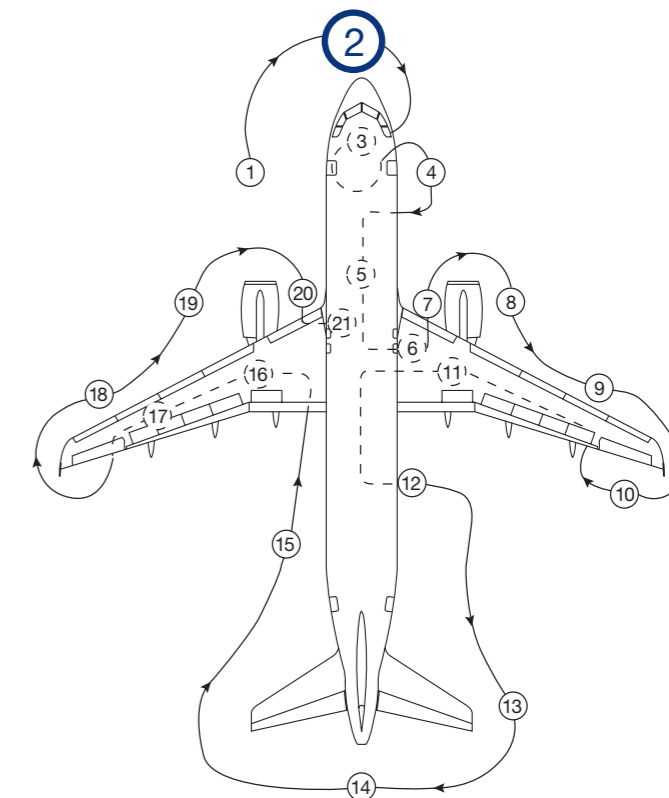
② NOSE SECTION

Prior to the flight, the aircraft spent a few hours on the stand. Storm conditions prevailed during the ground time. Pitot probes were not protected with covers and became obstructed. This was not noticed before take-off.

- Adhering to improved pitot maintenance program;
- Checking pitot reliable condition during the pre-flight walk around check;
- Aborting take-off when unreliable airspeed condition is detected before V1.

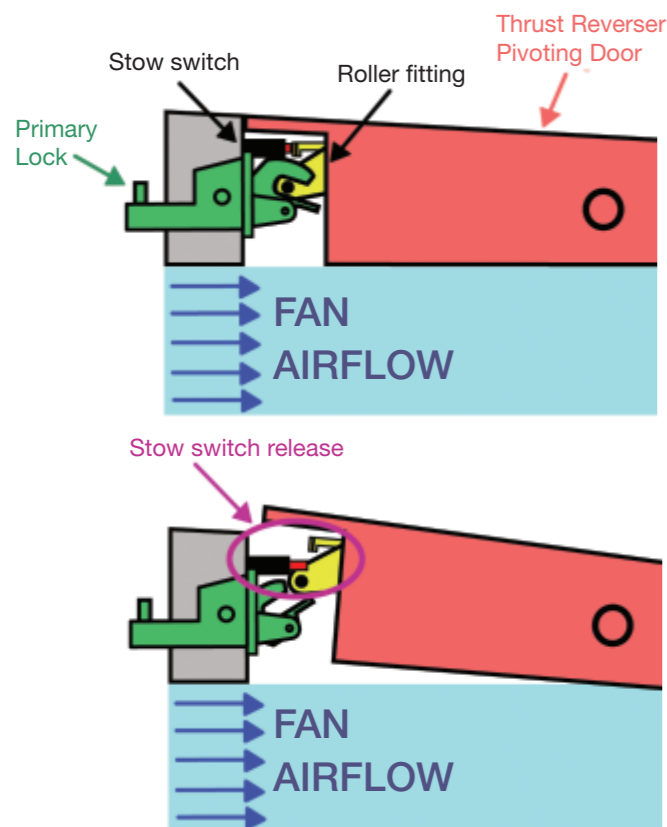
Fig 3: Release of the stow switch with Primary lock open

When the locking system is not pressurized, the secondary lock is engaged, ready to retain the actuator in its almost full-retracted position. If the primary lock fails, the door will extend slightly above the flush position before the secondary lock engages. In that case, the stow switch sensor is released (Fig 3), which leads to the generation of an “**ENG X REV UNLOCKED**” warning on the ECAM.

The above-described root causes usually lead to an unstable position of the primary lock between open and closed position. This unstable position switches to the open position (secondary lock activated) during the following flight due to engine acceleration/vibration. In most cases this happens during the takeoff run. An “**ENG X REV UNLOCKED**” warning is triggered and the crew performs a Rejected Take Off.

This is why troubleshooting has to be done in accordance with Ref. D or E in order to find the root cause and to apply the appropriate corrective action.
