The Airbus Safety Magazine

JULY 2008

Editorial

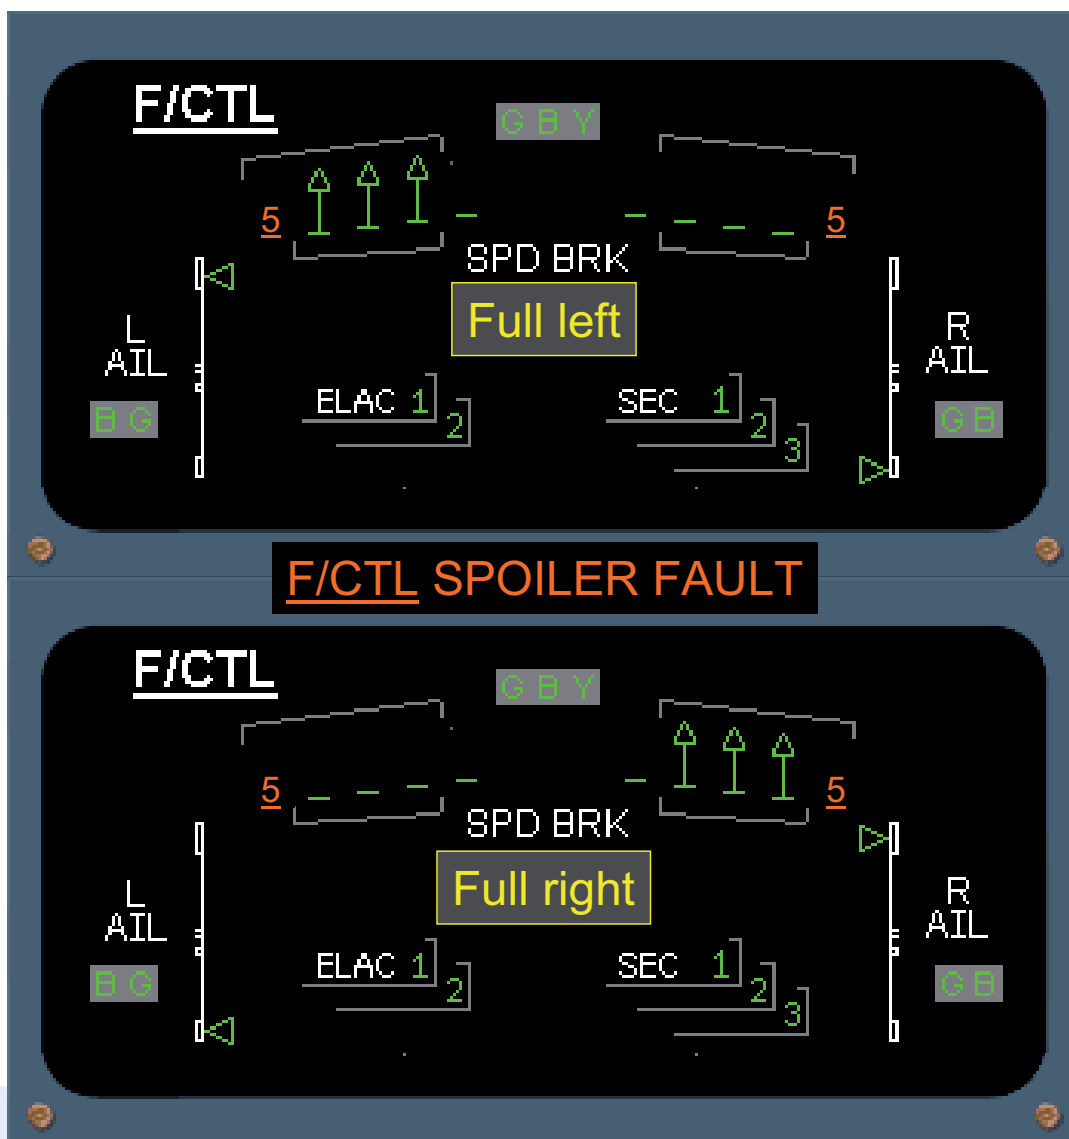
Figure 1: Spoiler 5 fault during F/CTL check

F/CTL SPOILER FAULT was triggered, and spoiler shown as FAULT RETRACTED (5) on the ECAM F/CTL page.

Figure 1 illustrates the messages displayed on the F/CTL page of their ECAM.

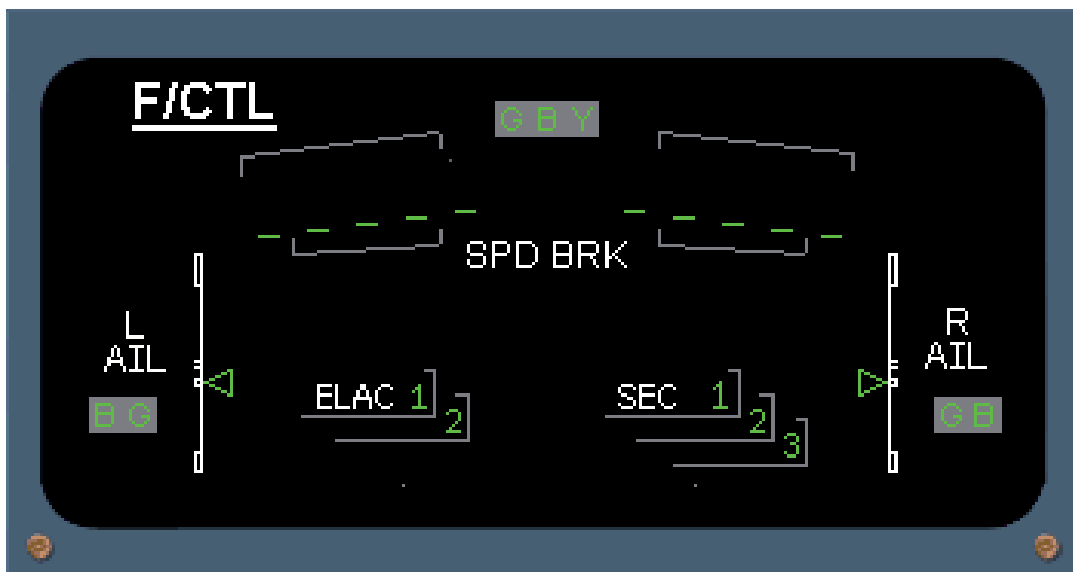
Figure 2: All GREEN after SEC reset

i.e. F/CTL SPOILER FAULT cleared and spoilers 5 were displayed back to GREEN on the F/CTL page (fig.2).

Through the SEC reset, the monitoring system of the spoilers was reinitialized and this cleared the fault message. The faulty condition, however, remained.

| 27 | ELAC or SEC malfunction | ELAC or SEC | <p>WARNING : Do not reset more than one computer at a time.</p> <ul style="list-style-type: none"> · It is possible to reset flight control computers in flight, event if not requested by the ECAM, provided only one reset is performed at a time: For the ELAC only, in case of uncommanded maneuvers during the flight, it is not recommended to reset the ELAC. <p>Note :</p> <ul style="list-style-type: none"> · <i>When an ELAC reset is performed on ground the crew must check the pitch trim position.</i> · <i>If a reset is performed on ground, the flight crew must then perform a flight control check, as per SOP.</i> |

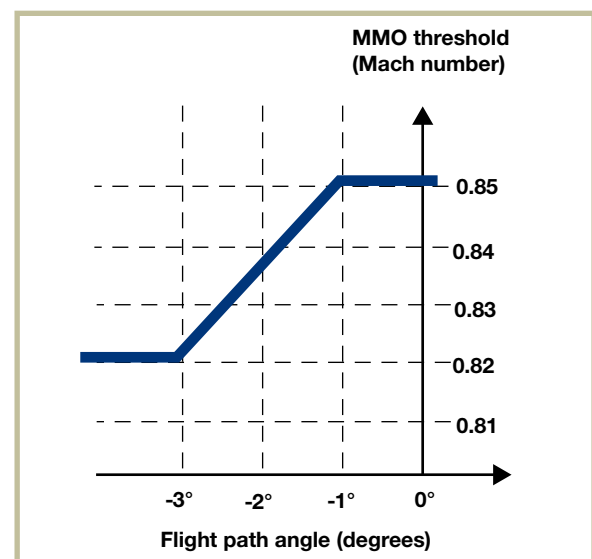
Figure 3: L84/L93 Mach threshold for HSP activation/AP disconnection.

In the L84/L93 standards, the Mach threshold is a function of the Flight Path Angle and is identical for the whole A320 family. The main aim is to have a better protection of the aircraft during cruise (*fig. 3*).

In order to avoid significant altitude excursions and AP disconnection unawareness in case of VMO/MMO exceedance, Airbus recommends installation of :

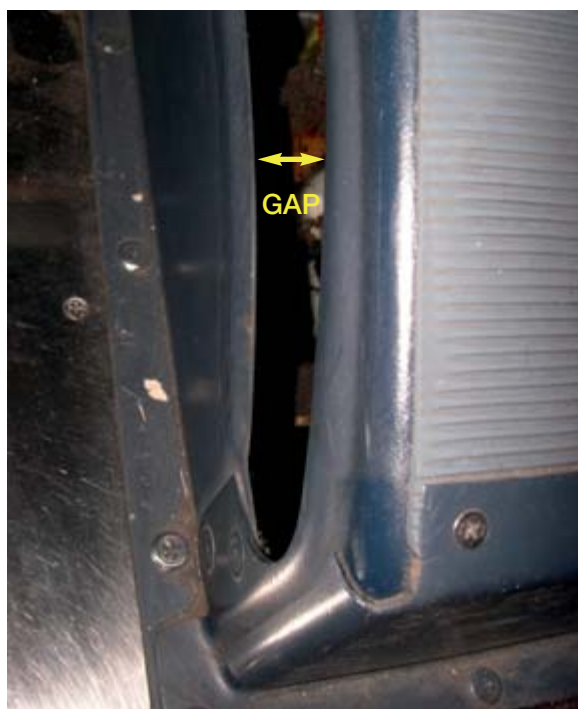
*Protective cover
with no brush*

The original cockpit pedals assembly covers presented a 5 cm open gap, to allow free movement of the rod connecting the pedal to the brake mechanism.

This unprotected gap let objects like pens or calculators slip into the braking mechanism.

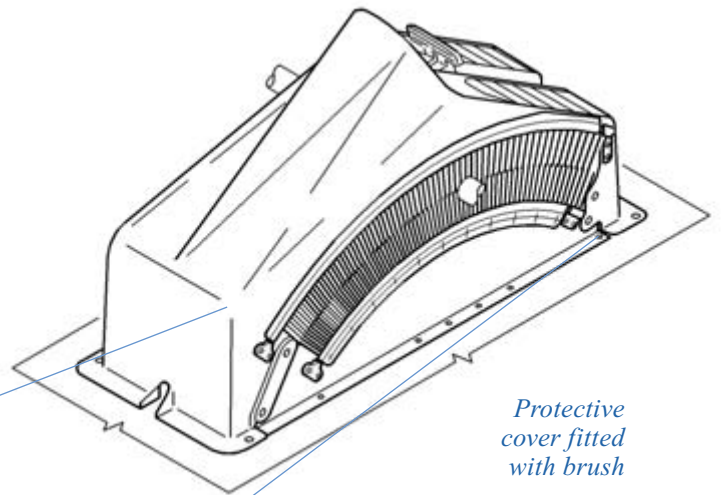
Protective cover fitted with brush

The first events were reported on A340 aircraft and new pedal covers with brush were developed for the A330/340 family. Due to similarity in design, a similar cover was introduced on the A320 family as well.

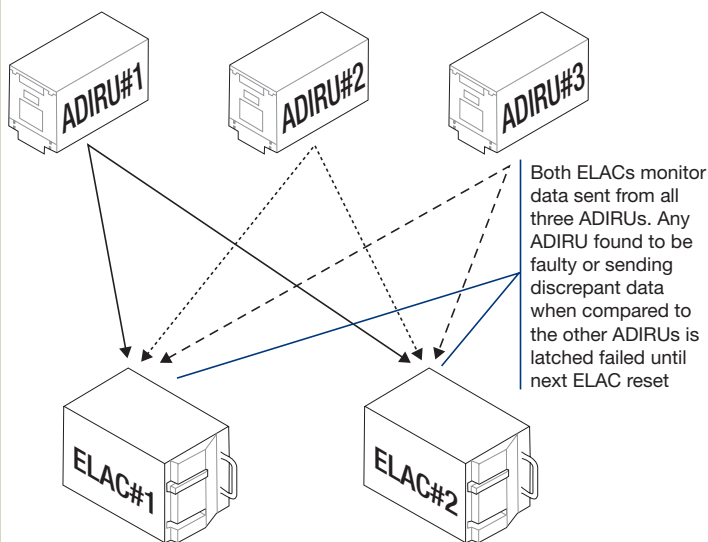
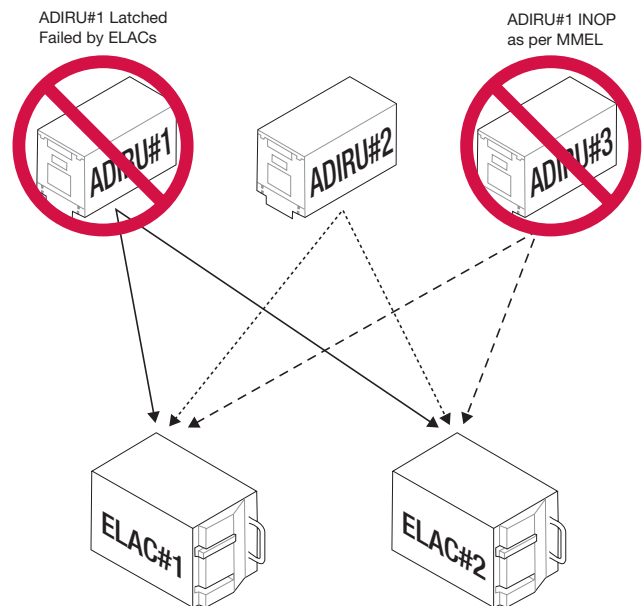
Airbus recently investigated an event in which it was found that an aircraft departed in Alternate Flight control law following maintenance actions not performed fully according to AMM procedure. The circumstances of this event were as follows: During flight an ADR#1 (Air Data Reference) fault was detected. The ELAC (Elevator and Aileron Computer) on detecting this fault, latched the ADR#1 as failed until its next reset. The ELAC subsequently used only ADR#2 and #3 data for calculations.

Upon landing, the maintenance crew swapped ADIRU#1 and #3, consequently the faulty ADIRU#1 became ADIRU#3. ADIRU#3 was therefore placed INOP as per MEL and the aircraft dispatched. At no point was an ELAC & SEC reset or aircraft electrical power reset performed. The consequence of this was significant: the ELAC kept its memory of ADR#1 Fault latched from the

previous flight. In addition it detected that the ADR#3 was INOP. Without ADR#1 or #3, only ADR#2 was considered available. Under these conditions the Electronic Flight Control system is only capable of operating in Alternate Law.

Had the maintenance crew correctly followed the AMM, including the ELAC reset, then the ADR#1 fault latched by the ELAC would have been reset and the Alternate law condition avoided.

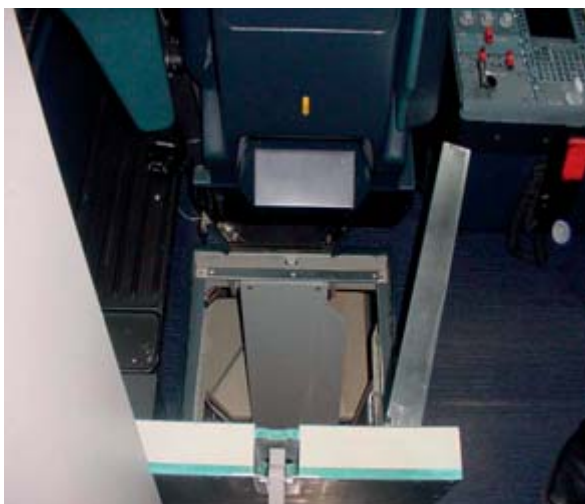
Figure 1: Open access hatch seen from cockpit door (prototype of protective arm shown)

Airbus has received reports of cabin attendants falling through the avionics hatch door located in the cockpit, when it is open for maintenance purposes. In most of the cases the cabin attendant hurt him/herself only slightly and could continue his/her duty. But there were also some occurrences where the cabin attendant couldn't continue his/her duty.

The avionics compartment access hatch is located in the cockpit behind the captain's seat. It opens upwards from front to back. When the hatch is open, it rests vertically and covers approximately 80% of the corridor width. This makes the hatch position noticeable and requires care to be taken to move around it when entering the cockpit. Therefore anyone entering the cockpit while the hatch is open should notice it (see fig. 1 and 2).
