The Airbus Safety Magazine

Edition July 2012

Issue **14**

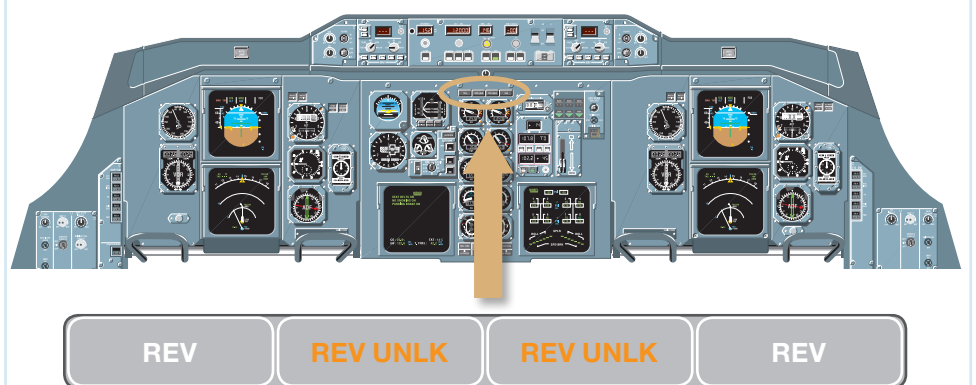
note 4

The thrust reverser lights indicate the operational status of the thrust reverser systems. When all lights are OFF, the translating sleeves are in the stowed position, the systems are latched.

REV UNLK LIGHTS

A light comes on amber when:

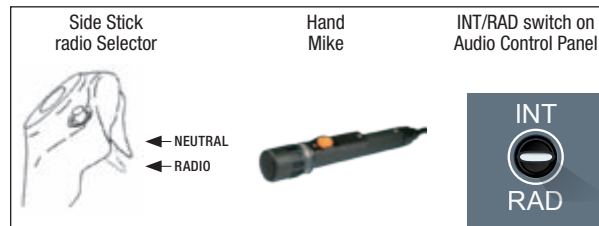
Figure 2
Push-To-Talk devices

On the A320 and A330/A340 families, when a transient loss of VHF communication is experienced in association with the triggering of the alert COM VHF EMITTING, the root cause can almost always be attributed to a jammed PTT device.

1. If any Push To Talk (PTT) transmission selector (sidestick radio selector, hand mike selector, or PTT switch is jammed in the transmit position, try to release it in order to remove the caution.
2. If unsuccessful, deselect the identified failed VHF/HF transmission keys on the associated Audio Control Panel (ACP) to remove the caution. This ACP should only be used in reception mode. The associated PTT transmission selectors must not be used.
