The Airbus Safety Magazine

01 | January 2005 |

Go-Arounds at Addis Ababa due VOR Reception Problems

As far as aeronautics systems are concerned, the pre-flight flight controls (F/CTL) check has existed since before the first powered flight. It aims at ensuring that flight controls respond to the pilot inputs, i.e. with no jamming, or movement limitation, or stiffness, or delayed or inadequate response. It is thus a key factor in the safe operation of the aircraft.

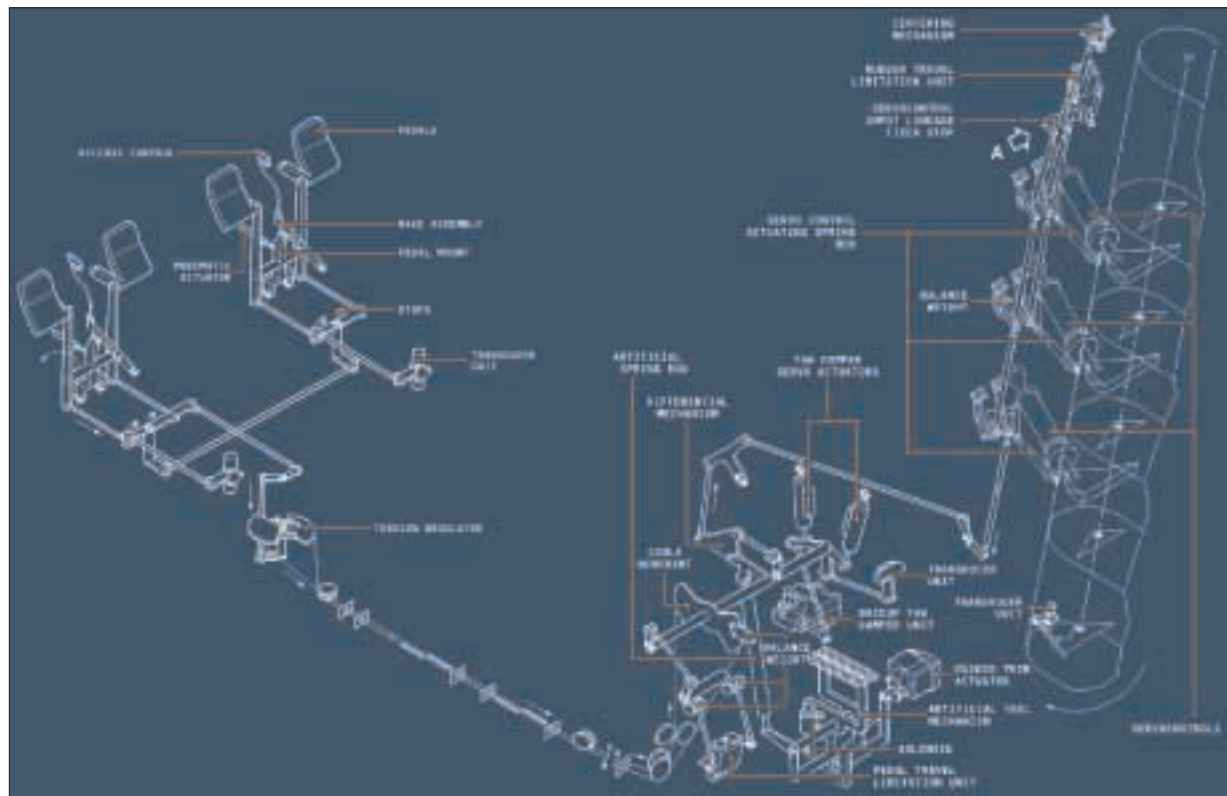
Figure 1 : A330 rudder system schematic

On any Airbus aircraft, the F/CTL check involves the elevators, ailerons, spoilers and rudder control systems. Not only the components activated with the control wheel, control column and pedals, but the whole system. Let us refer to figure 1 and take the rudder axis of an A310 as an example in order to illustrate this comment.

The majority of the components represented in figure 1 are involved:

The F/CTL check is thus not limited to the relationship in between the servocontrols, observed with the surface position indicators, and the controls at cockpit. The whole system is checked.

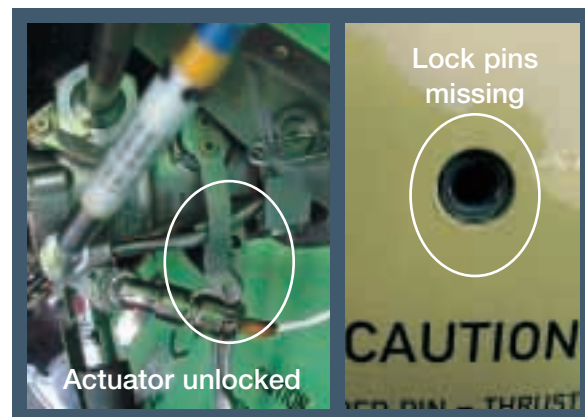
- The HCU deactivation was done properly following the AMM procedure:
 - “A. Deactivation of the Thrust Reverser HCU” procedure.
- The following AMM procedure steps were not performed , because it was not possible to do so while the thrust reverser actuators were lock wired in the unlocked position:
 - “B. Manually move the translating sleeves to the fully retracted position”
 - “C. Lock the Left and the Right Translating sleeves”
- Finally the last AMM procedure step was not done.
 - “D. Put the locking actuators in the locked position”

Due to the combination of having:

- The HCU deactivated (leading to no hydraulic power to the actuators)
- And the actuators not locked
- And the lock-out bolts not properly installed on the translating sleeves,

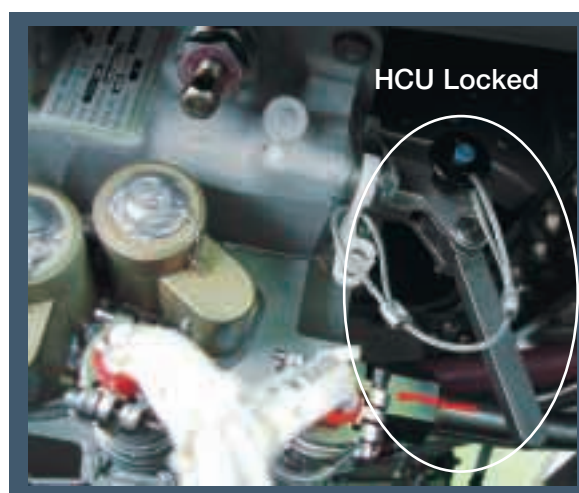
Figure 6: Deactivated Flight Condition

The "ENGX REVERSE UNLOCKED" and the "REV" Amber messages should not be present on ECAM following a proper thrust reverser deactivation. **They are both NO DISPATCH warnings.**
