The Airbus Safety Magazine

03 | December 2006

Trimmable Horizontal Stabilizer Damage

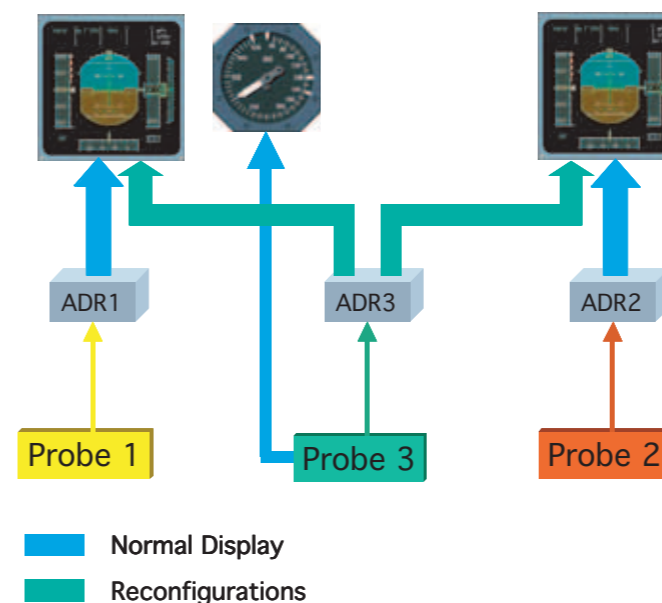
In the event referred to above, no reconfiguration to ADR3 was reported, and the information displayed on the standby indicator was the sole reliable.

The behavior of the systems described in paragraph 2 resulted from the AFS (Auto Flight Systems) and EFCS detecting the discrepancy between the 3 airspeeds. Since the monitoring is based on a comparison of the different speeds, and since all 3 were different, the systems could not recognize CAS3 as being the reliable speed. CAS3 being the odd among the 3 airspeeds, it was rejected at first. In this case, however, all 3 data were rapidly rejected by EFCS for computation till the end of the flight.

CAS3 being accurate during subject event, and over speed warning being computed on the basis of an «OR» condition of CAS1, 2 & 3 versus VMO/MMO, the over speed situation indicated by the Flight Warning System was actual.

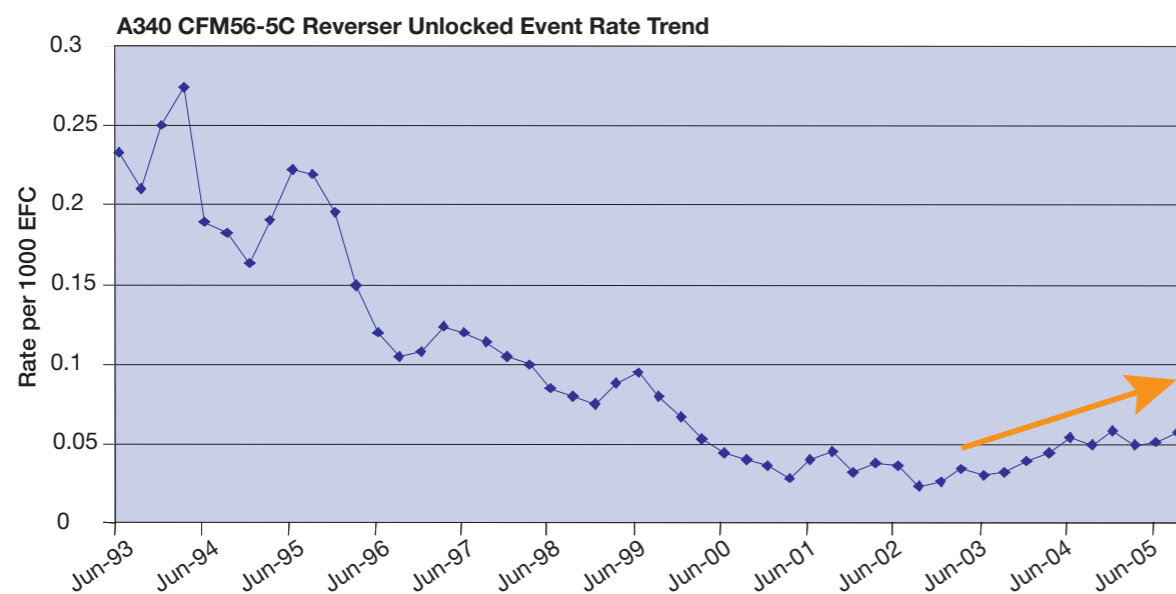
Fig 1: Trend of the "Rev Unlock" event rate since Entry Into Service

However, this rate has been rising again in the last 2 years, as highlighted on Figure 1.

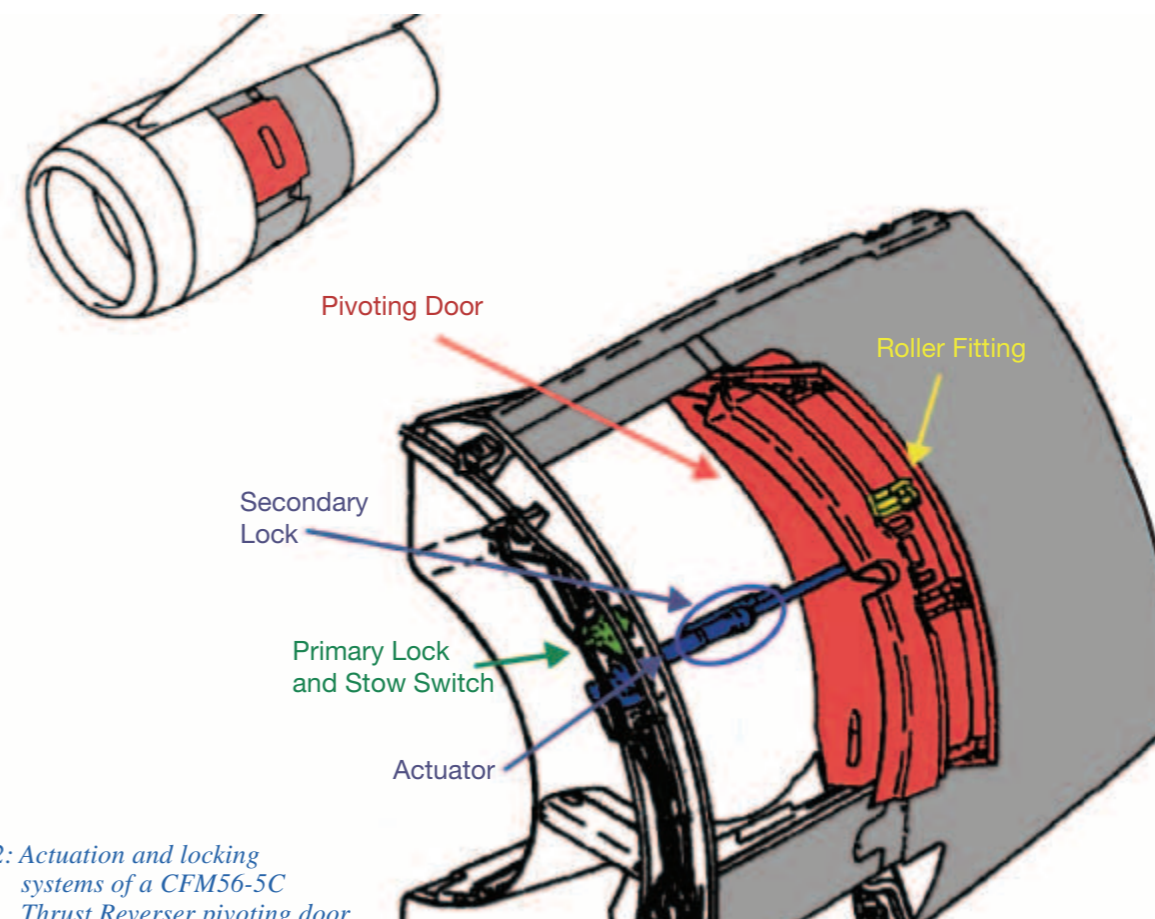
Fig 2: Actuation and locking systems of a CFM56-5C Thrust Reverser pivoting door

When the locking system is not pressurized, the secondary lock is engaged, ready to retain the actuator in its almost full-retracted position. If the primary lock fails, the door will extend slightly above the flush position before the secondary lock engages. In that case, the stow switch sensor is released (Fig 3), which leads to the generation of an “**ENG X REV UNLOCKED**” warning on the ECAM.

The continuous feedback from the operators allowed identifying that the primary lock rotating cam can fail to hook the roller-fitting due to:

The above-described root causes usually lead to an unstable position of the primary lock between open and closed position. This unstable position switches to the open position (secondary lock activated) during the following flight due to engine acceleration/vibration. In most cases this happens during the takeoff run. An “**ENG X REV UNLOCKED**” warning is triggered and the crew performs a Rejected Take Off.

Maintenance will find a pivoting door ajar on the affected engine. Pushing the door back in its closed position will engage the primary lock and clear the issue for the next takeoff. But as the root cause has not been addressed it is likely that an “**ENG X REV UNLOCKED**” will appear after some thrust reverser actuations.

This is why troubleshooting has to be done in accordance with Ref. D or E in order to find the root cause and to apply the appropriate corrective action.

In addition to those practices, a final solution will introduce a set of improvements to the locking system by addressing the above root causes. See also ref. G for further information.
