The Airbus Safety Magazine

JULY 2008

Editorial

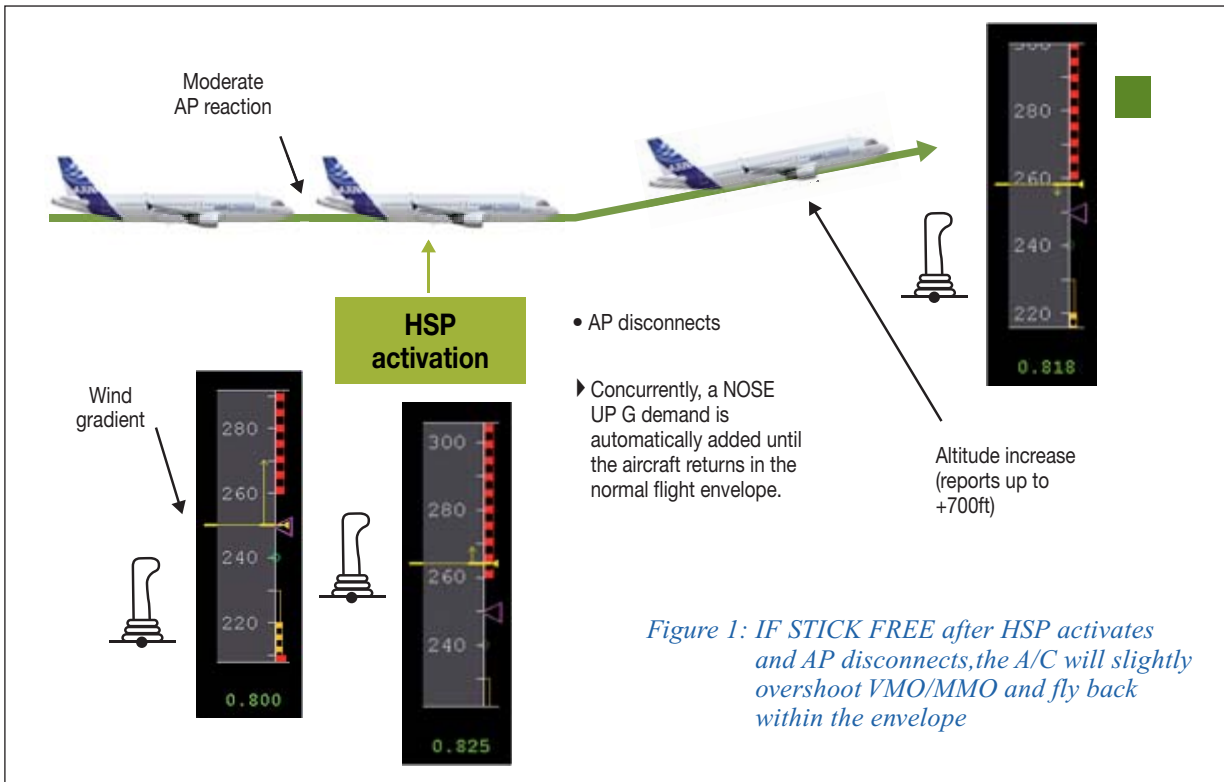
The aircraft typically has the Auto Pilot engaged, and the wind gradient will lead it to exceed the High Speed protection (HSP) threshold (the speed or Mach number at which the HSP activates depend on the flight conditions, but do not exceed $VMO+6kt$ or $MMO+0.015$). The triggering of the HSP will automatically disconnect the Auto Pilot.

From experience, the altitude excursion is limited to less than 700 ft (*fig. 1*).

In order to avoid significant altitude excursions and AP disconnection unawareness in case of VMO/MMO exceedance, Airbus recommends installation of :

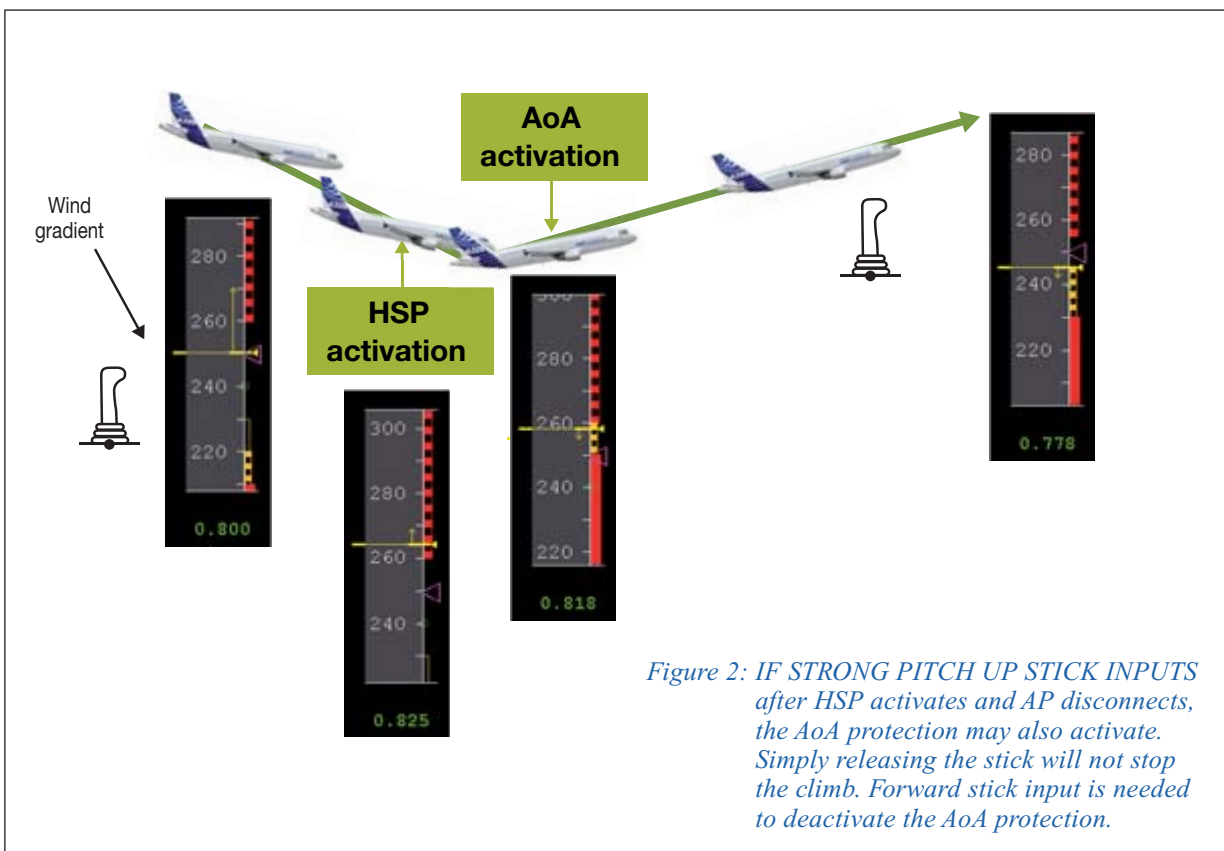
This means that the aircraft will climb at the highest AOA value for as long as the protection is activated. Since deactivation may only be achieved through nose down side stick input, simply releasing the stick will not stop the climb.

Delayed reaction from pilots in applying forward stick input results in large altitude excursions (*fig. 2*).

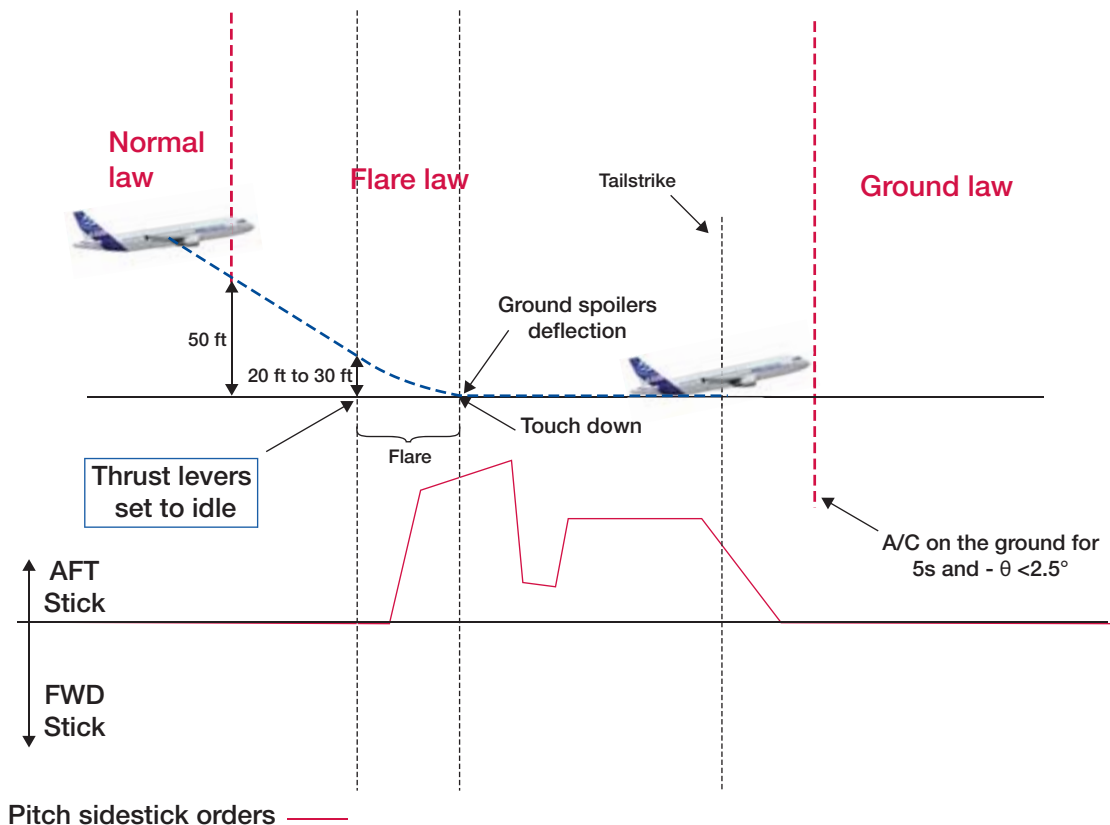
Most of the tailstrikes on A320 family aircraft occur during landing in manual mode (Auto Pilot OFF), when the sidestick is maintained in the aft position after touch down (Fig1).

Figure 1: Normal landing with sidestick maintained AFT after the touch down.

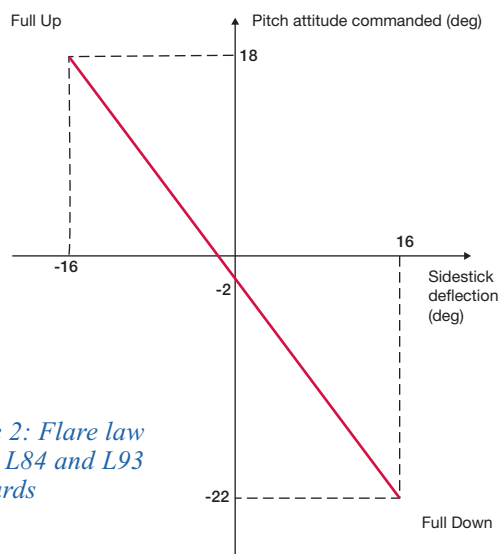
- A pitch sidestick deflection corresponds to a commanded pitch attitude.
- The maximum commanded pitch attitude with full back stick is 18 degrees (fig. 2).

Figure 2: Flare law before L84 and L93 standards

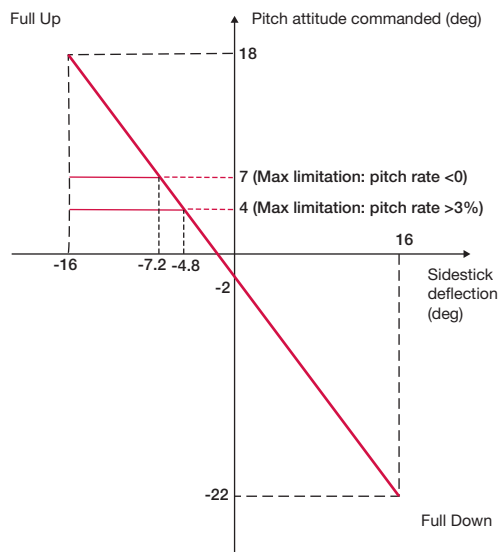
This limitation is triggered by the ground spoiler extension, thus ensuring that it will be active only during landing. It is therefore deactivated during the take off and go-around phases.

Simulations with the improved control laws have confirmed the following:

- No impact on the landing performance
- The usual flare is not modified
- No interference in case of go-around or during take off due to the ground spoiler condition

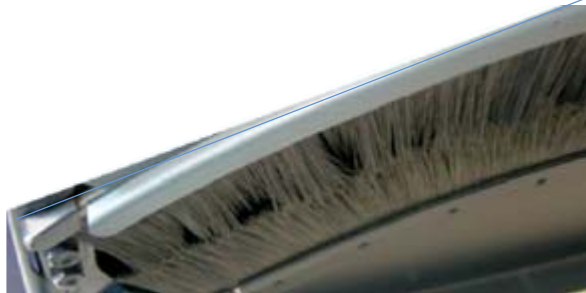
Detail of brush

The first events were reported on A340 aircraft and new pedal covers with brush were developed for the A330/340 family. Due to similarity in design, a similar cover was introduced on the A320 family as well.

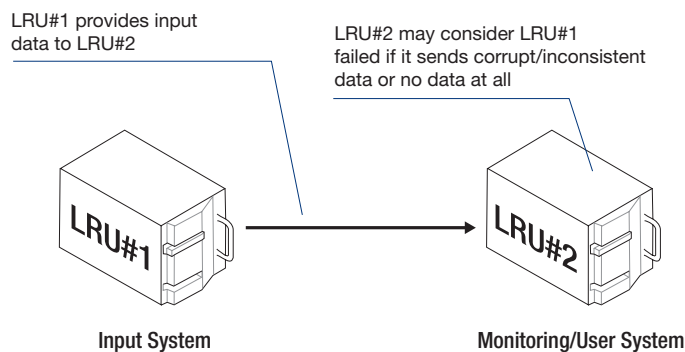
The reset is often necessary to clear faults recorded by systems before or even possibly during maintenance. Some systems (the example below illustrates this) use fault latching mechanisms. That is to say that once a fault has been detected, the input system will be considered unavailable until the user system is next reset.

Typically if maintenance actions are performed to correct a given fault, it can be necessary to reset user systems to ensure that they consider the input system operational again.
