Safety first

The Airbus Safety Magazine

Edition January 2011

- ▶ What is stall?
How a pilot should react
in front of a stall situation
- ▶ Minimum control speed tests
on A380
- ▶ Radio Altimeter erroneous values
- ▶ Automatic NAV engagement
at Go Around

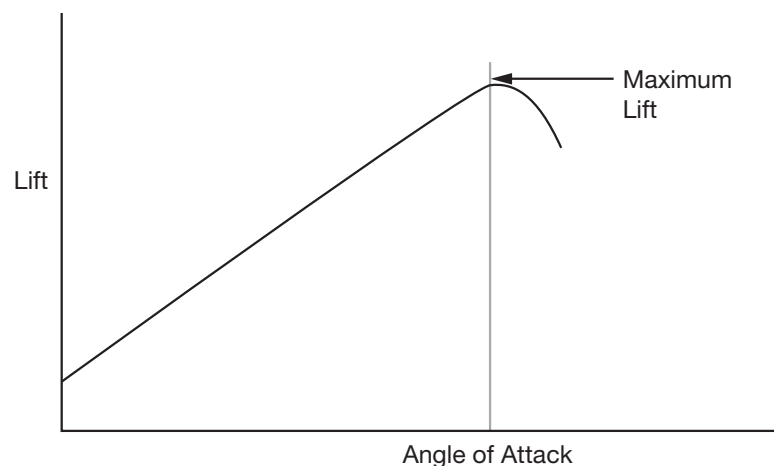
The lift coefficient increases as a function of the Angle of Attack (AoA) up to a value, called Maximum lift, where it starts to decrease.

For a given configuration, a given speed and a given altitude, the lift is only linked to the AoA.

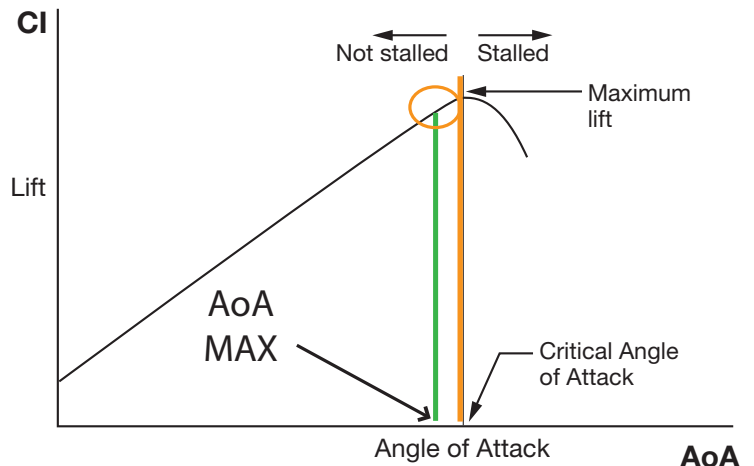
Figure 1
In NORMAL LAW, the EFCS limits the AoA to a value lower than AoA STALL.

In NORMAL LAW, the Electronic Flight Controls System (EFCS) takes into account the actual AoA and limits it to a value (AoA MAX) lower than AoA STALL (fig. 1).

The EFCS adjusts the AoA MAX limitation to account for the reduction of the AoA STALL with increasing Mach number.

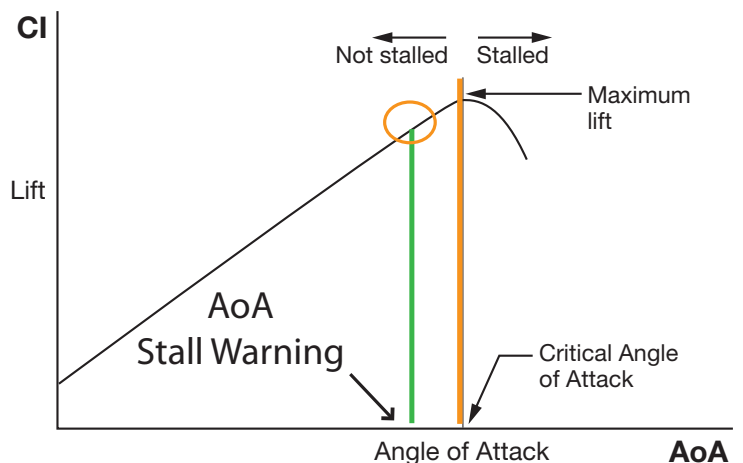
Figure 2
In ALTERNATE and DIRECT LAW, the aural Stall Warning is set at a value lower than AoA STALL.

In both ALTERNATE and DIRECT LAW, the aural SW is set at a value called AoA Stall Warning (AoA SW), which is lower than the AoA STALL (fig. 2).

Typically, in cruise at high Mach number and high altitude, at or close to the maximum recommended FL, there is a small margin between the actual cruise AoA and the AoA STALL. Hence, in ALTERNATE or DIRECT LAW, the margin with the AoA SW is even smaller.

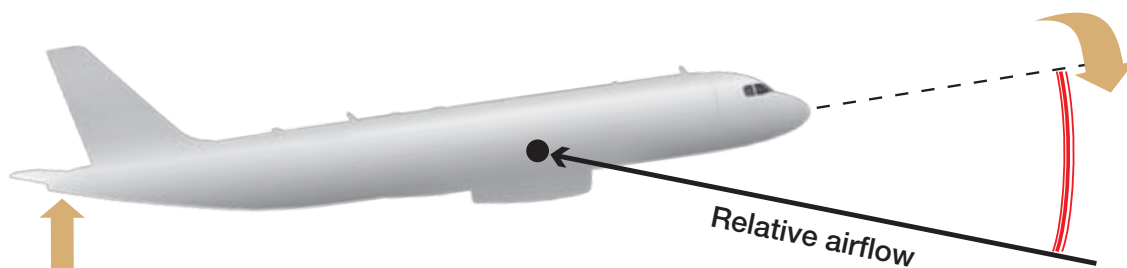
Figure 3
Pitch control
is a direct
AoA command

The pitch control is a direct AoA command (fig. 3).

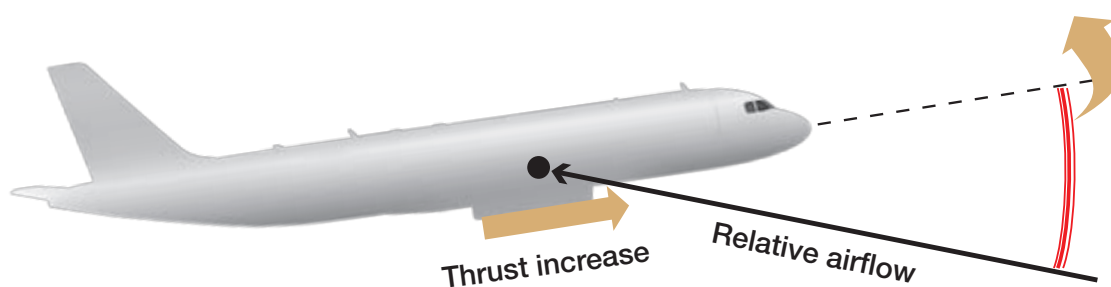
Figure 4
Adding thrust
leads to an
increase in AoA

The AoA decrease may be obtained indirectly by increasing the speed, but adding thrust in order to increase the speed leads to an initial adverse longitudinal effect, which tends to increase further the AoA (fig. 4).

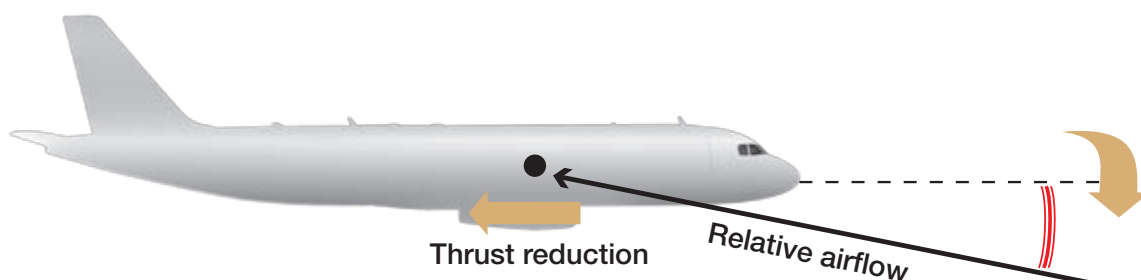
Figure 5
Reducing thrust
leads to a
decrease in AoA

Conversely, the first effect of reducing the thrust is to reduce the AoA (fig. 5).

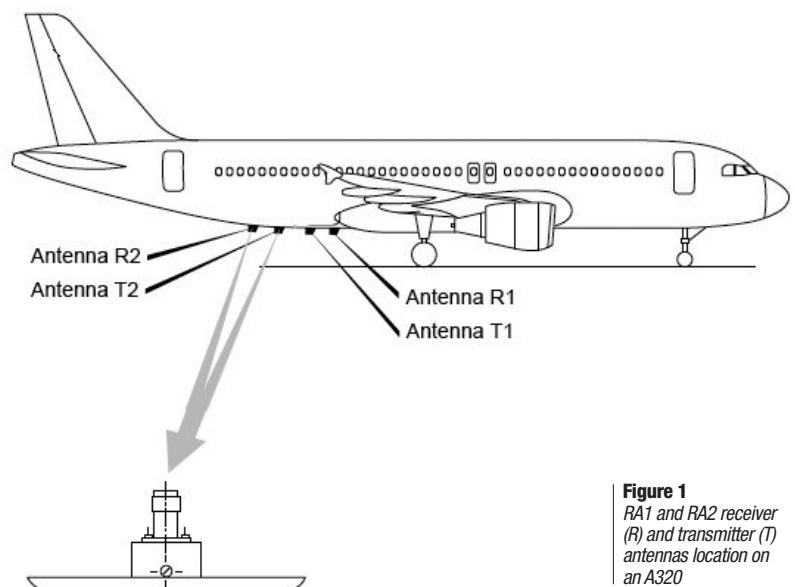
Figure 1
RA1 and RA2 receiver (R) and transmitter (T) antennas location on an A320

All Airbus aircraft, except the A380, are equipped with two RAs, which provide height information to several aircraft systems (fig. 1).

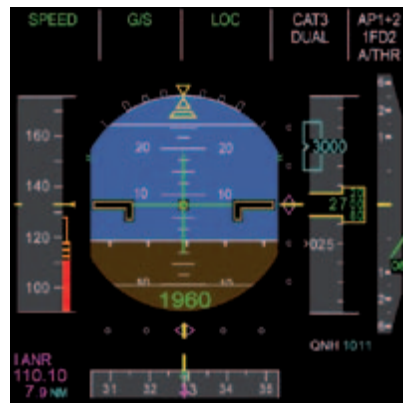
Figure 2
Both RAs provide correct height of 1 960 ft

▶ Figure 2 shows the crew's PFDs before the RA1 issue. Both RAs function properly and provide the same height of 1 960 ft. The vertical mode is on G/S, and the lateral mode is on LOC. The A/THR is engaged in SPEED.

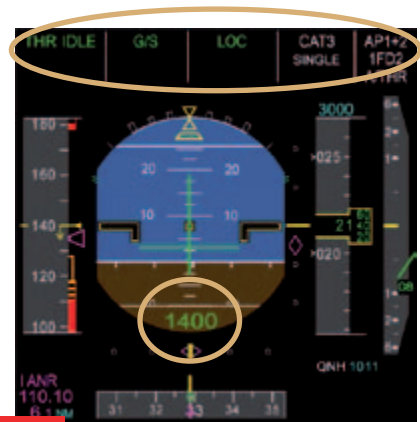
Figure 3
Erroneous RA 1 reading is - 6 ft, correct RA 2 reading is 1 400 ft. Both AP/FDs are engaged

▶ Figure 3 RA 1 provides an erroneous height indication of - 6 ft, while RA 2 delivers the correct height of 1 400 ft.

Erroneous RA
